Fakel Burner Inspection

CONDOR Solutions carried out new inspection of the fakel burner in the facility of Lunscoe OPF in October 2016. The facility is owned by Sakhalin Energy whose major shareholders are the companies Shell and Gazprom. The facility of OPF is located in the Northeast coast of Sakhalin island in the Russian territory. It is located 7km in the inland region, at the place of influx of the gas-pipeline from the platform Lunscoe A. The entire facility takes the area of more than 62,000 m².

Bridge inspection on bustling section of the Trans-Siberian railroad by DroneProfi & FlyAbility

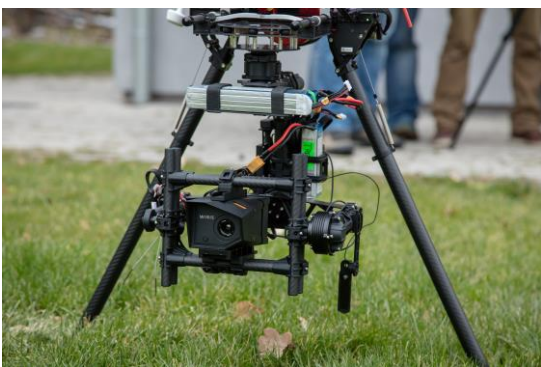
Thermal imaging camera Workswell WIRIS mounted on a drone

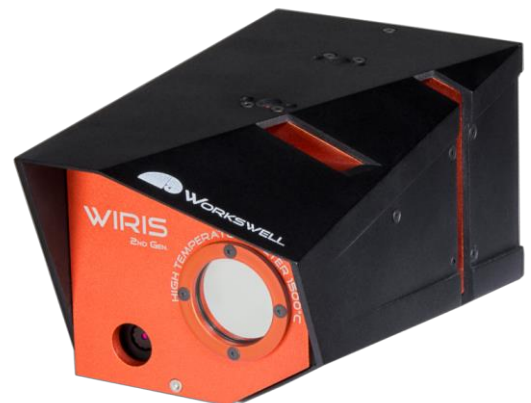
*Thermal imaging camera Workswell WIRIS
2nd gen with high temperature filter.*

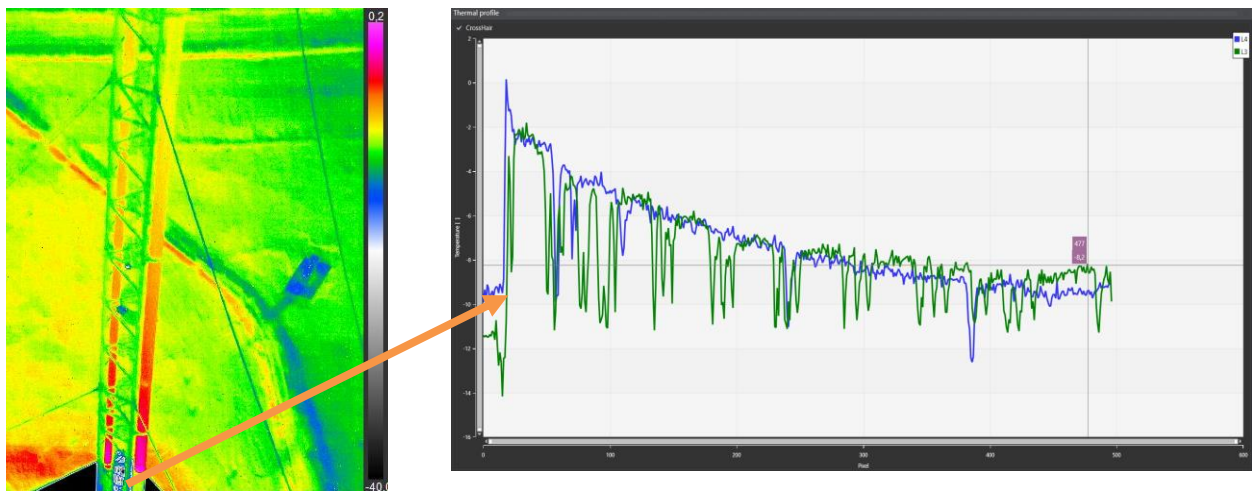
Thermal profile measured on the surface of burner system. Software Workswell CorePlayer was used for thermogram analysis.

In the first part, we found out the temperature of the mast and the rising pipeline of the system of high and low pressure; we also prepared the temperature profile, as shown in the figure. The graph and thermogram clearly show where the pipeline isolation finishes. At this point, the temperature sharply increases up; and consequently the temperature gradually decreases together with the height, up to the upper part - the shank; then the temperature rapidly increases up again. Up to the temperature of about 2,000°C.

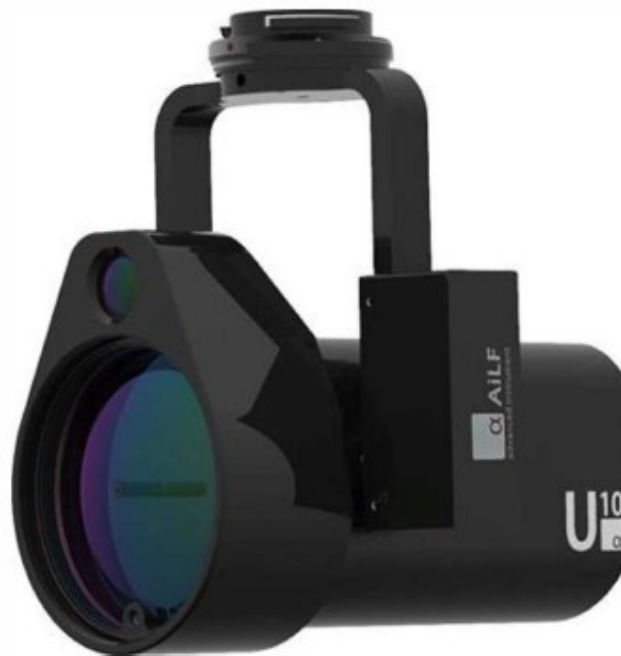
The U10 is light-weight, high-sensitivity gas detector based on Tunable Diode Laser Absorption Spectroscopy (TDLAS), which enables rapid identification of methane from up to 100m away, or at a concentration as low as 5 ppm.m. Powered by DJI SkyPort, the U10 can be seamlessly integrated with DJI Matrice 200 Series V1 and V2 platforms.

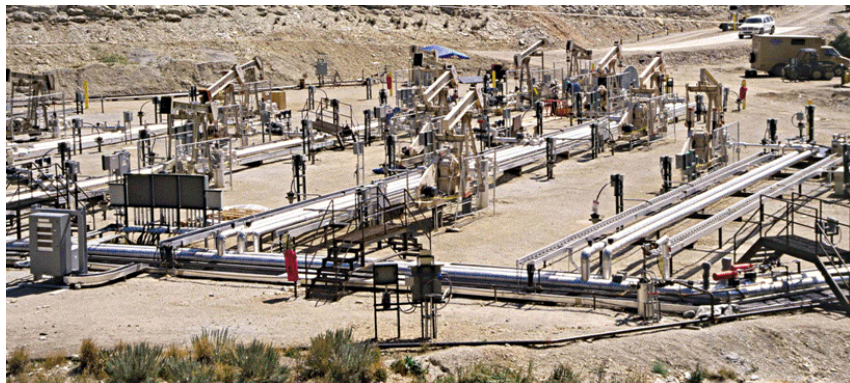
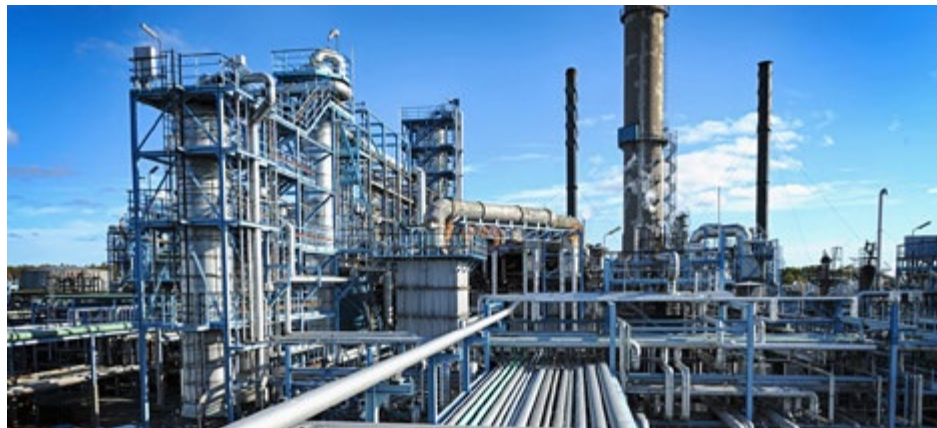
U10 UAV Based Laser Methane Leakage Detector			
Method of Detection	TDLAS	Detection target	Methane(CH ₄)
Stationary Detection Limit	5 ppm·m	Detection Laser	Class IIIR
Response Time	25 ms (0.025s)	Operating Temperature	-20 ~ 50°C
Sampling Rate	500KHz	Operating Humidity	<90%RH, no condensation

Detection Concentration Range	0~50,000 ppm·m	Size	155 x 90 x 100 mm
Max Detection Distance	100 m	Weight	534g
Camera	Video at 720 p	Supported Aircraft	DJI Matrice 200 Series, Matrice 200 Series V2

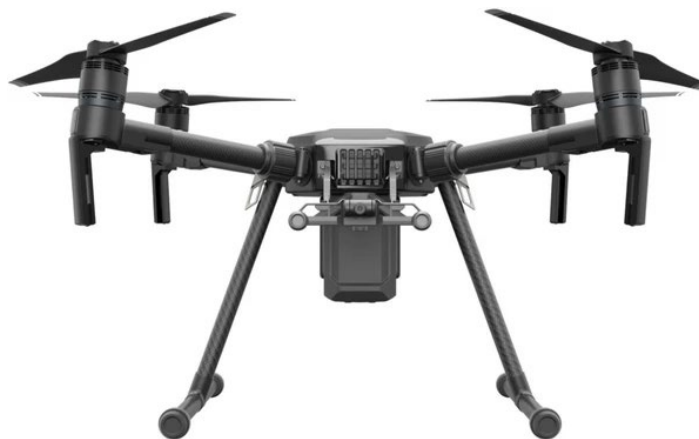
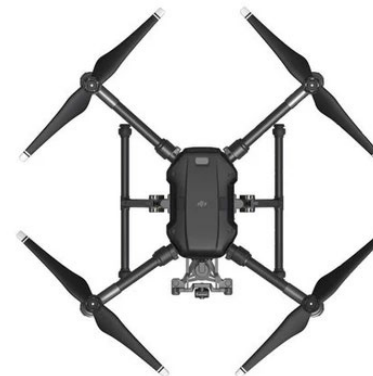
UAV Platform

Model	Matrice 210 RTK
Package Dimension	31.1×15.4×11.4inch (790×390×290mm)
Dimension (unfolded)	34.9×34.6×16.1 inch (Unfolded, 887×880×408 mm)
Dimension (folded)	28.2×9.5×9.3 inch (Folded, 716×242×236 mm)
Folding Method	Folded Inward
Diagonal Wheelbase	25.3 inch (643 mm)
Number of Batteries	Two (TB50s and TB55s)
Weight (TB50)	Approx. 4.27 kg
Weight (TB55)	Approx. 5 kg
Max Takeoff Weight	6.14 kg
Max Payload (2 TB50)	Approx.1.87 kg (with two standard batteries)
Max Payload (2 TB55)	Approx.1.14 kg (with two optional batteries)
Hovering Accuracy (P-mode with GPS)	Vertical: ±1.64 feet (0.5 m) or ±0.33 feet (0.1 m, Downward Vision System enabled) Horizontal: ±4.92 feet (1.5 m) or ±0.98 feet (0.3 m, Downward Vision System enabled)
Max Angular Velocity	Pitch: 300°/s, Yaw: 150°/s
Max Pitch Angle	P Mode: 35° (Forward Vision System enabled: 25°) ; A Mode: 35° ; S Mode: 35°
P Mode: 35° (Forward Vision System enabled: 25°) ; A Mode: 35° ; S Mode: 35°	16.4 ft/s (5 m/s)

Max Descent Speed	Vertical: 9.8 ft/s (3 m/s)
Max Speed	P-mode: 61 kph (17 m/s); S-mode/A-mode: 83 kph (23 m/s)
Max Service Ceiling Above Sea Level	1.55 miles (2500 m)
Max Wind Resistance	32.8 ft/s (10 m/s)
Max Flight Time(No Payload, with TB50)	23min
Max Flight Time(No Payload, with TB55)	32min
Max Flight Time(Full Payload, with TB50)	13min
Max Flight Time(Full Payload, with TB55)	24min
Motor Model	DJI 3515
Propeller Model	1760S
Retractable Landing Gear	Standard
Operating Temperature	-4° to 113° F (-20° to 45° C)
IP Rating	IP 43

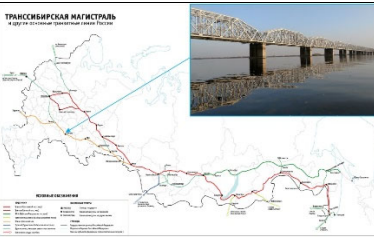
After reviewing the visual data they collected for the spans, inspectors found some loose mounts (shown below) but otherwise there were no major defects identified. The drone's signal quality remained stable throughout the mission, with no signal interference at all detected throughout the mission, either from the metal structure or from passing trains. Also, since the drone was operating below or inside the bridge spans, there was no turbulence from the passing trains to interfere with its stability while in flight.

FlyAbility in action	Results of faults;	A map highlighting the location of the Oktyabrsky Bridge;
